FPL Saves Servo Valves

Prevents Unnecessary Downtime & Reduces Maintenance Costs

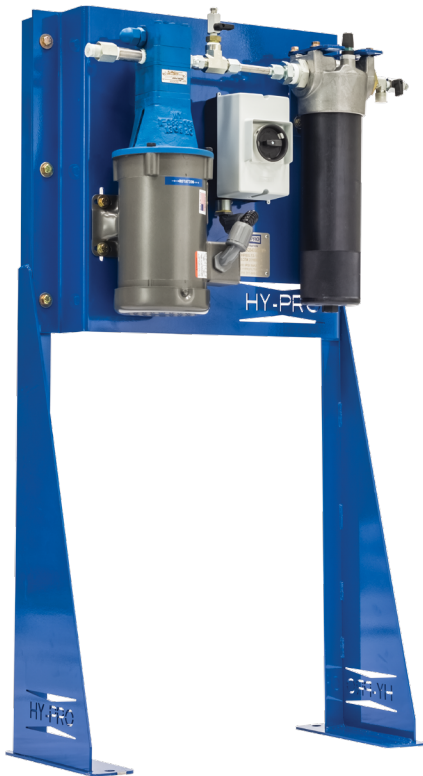
Hy-Pro suggested implementing a total system cleanliness approach by adding a 1gpm FPL off-line filter panel fitted with a $\beta_{2.5[\mu]} > 1000$ filter element to the 25 gallon hydraulic reservoir to reduce contamination levels and extend valve life. A spin-on breather would also be added to the reservoir to exclude solid particulate ingress from the atmosphere.

1 FPL Spin-On Breather

Hy-Pro designed, manufactured and shipped a custom FPL filter panel specific to the customer's requirements in 1 week. Hy-Pro and the local distributor were on site to install and startup the system. Days after installing FPL and breather the operating ISO code had been reduced from 22/20/17 to 13/9/7 which represents a 99.8% reduction in particles $4\mu_{\text{m}}$ and larger. Subsequently, filter panels and breathers were added to each of the 34 other tire grinding systems.

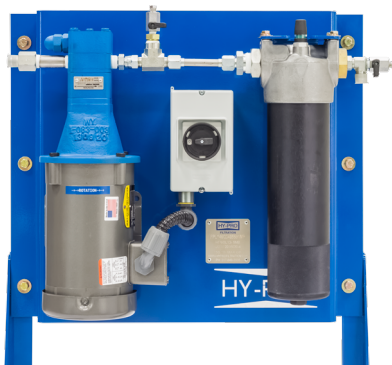
Beginning ISO Code
22/20/17

Current ISO Code
13/9/7
